# INSPECTION REPORT

**Injector Head 6100**  
 Tool Serial No.: **Crash Cage**

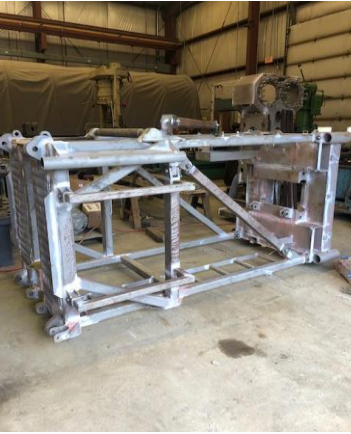
Comments: **8 Cracked weld found on initial inspection 9-27-18. Weldes were repaired and Crash Cage pull tested**  
**All repaired welds and load bearing welds and padeyes were reinspected 10/12/18 and no defects were found**
